Can Acrylic Coatings save your Next Roof?

Source/Author: Robert Antrim, Cynthia Johnson, William Kirn, Walter Platek & Karen Sabo

This research paper explains the process of asphalt degradation over time and reveals the performance of acrylic maintenance coatings, site aged for six to 10 years, over both BUR and shingle roofs.

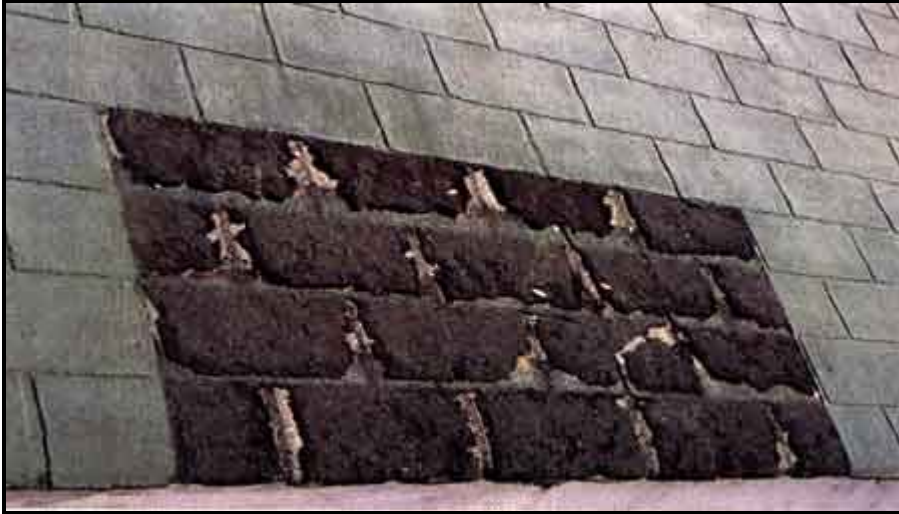
The photograph shows the effects of weathering over a 20-year period on a portion of an untreated asphaltic roof. The remainder of the roof was coated with an all-acrylic elastomeric roof coating about 10 years after it was built, and has resisted additional weathering. (Photo courtesy of Rohm and Haas Co., Philadelphia.)

After seven years of additional exposure in Spring House, PA, the roof was examined. The coated section clearly exhibited virtually no change in appearance, while the uncoated section was severely degraded. Similar experiments with built-up asphalt roofing mock-ups gave comparable results; the coated roof showed virtually no change while the uncoated section was severely degraded.
